**AIRCRAFT GROUND-FLOTATION INVESTIGATION
PART VII DATA REPORT ON TEST SECTION 6**

**W. BRABSTON and W. HILL, JR.
U. S. ARMY ENGINEER WATERWAYS EXPERIMENT STATION**

**TECHNICAL REPORT AFFDL-TR-66-43, PART VII
AUGUST 1966**

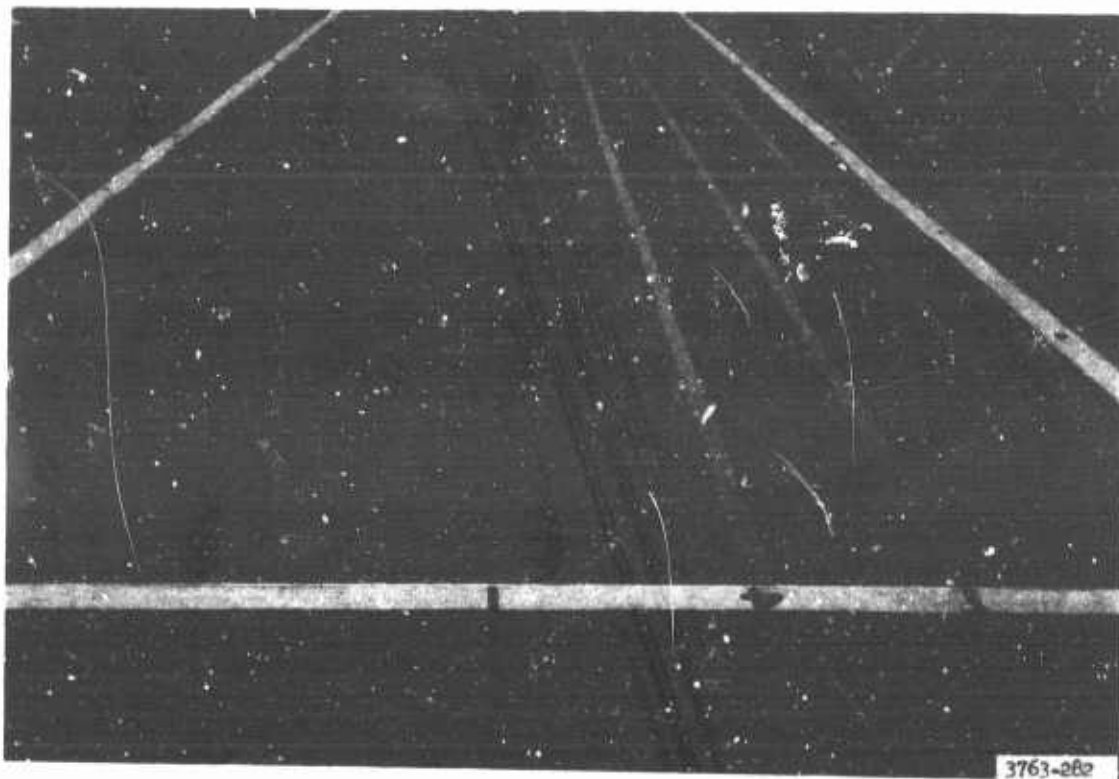
Item 1. Figure 12 shows item 1 prior to traffic. The item was still in good condition when measurements were recorded at 44 traffic coverages. Additional trafficking produced progressive deterioration of the item until it was considered failed due to roughness at 90 coverages (figure 13). The rated CBR was 2.9.

Figure 12. Lane 12, item 1, prior to traffic

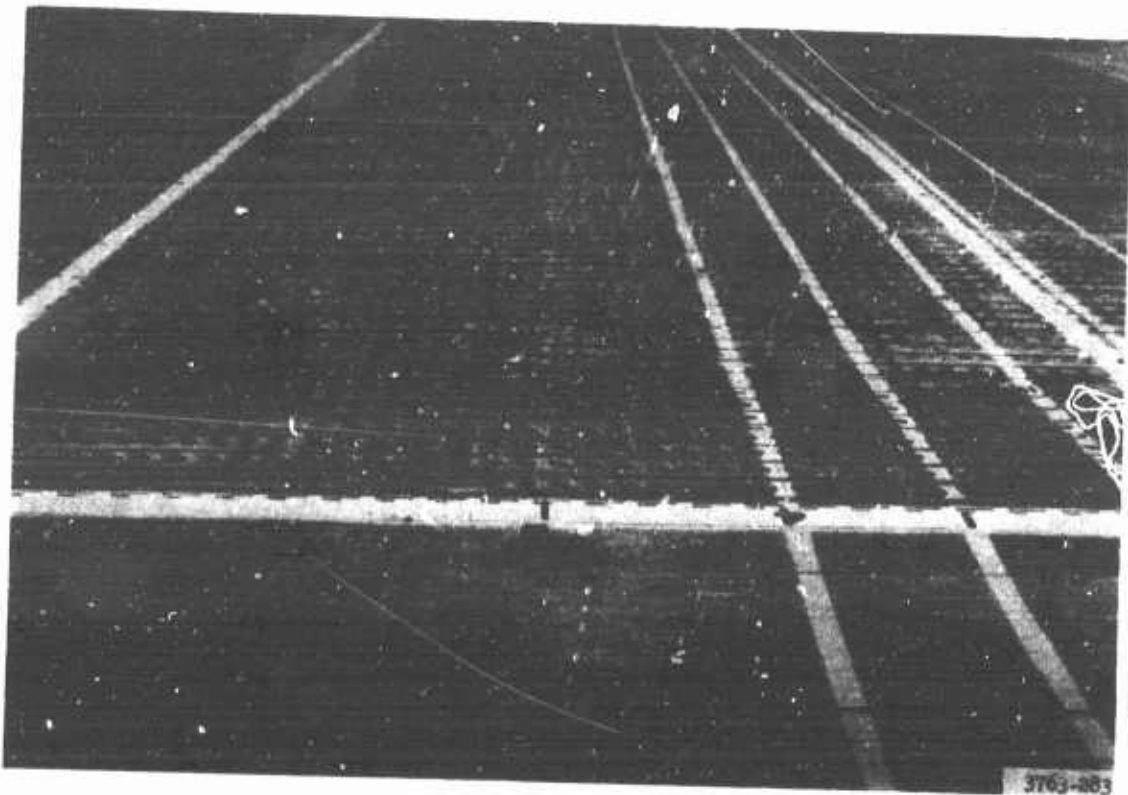
Item 2. Figure 14 shows item 2 prior to traffic. The item was considered failed due to roughness at 44 coverages (figure 15). At failure the plank ends along the mat joint line near the lane center were bent downward into the subgrade in contrast to the upward protrusion of plank ends encountered in previous test lanes. The rated CBR was 4.2.

Figure 14. Lane 12, item 2, prior to traffic

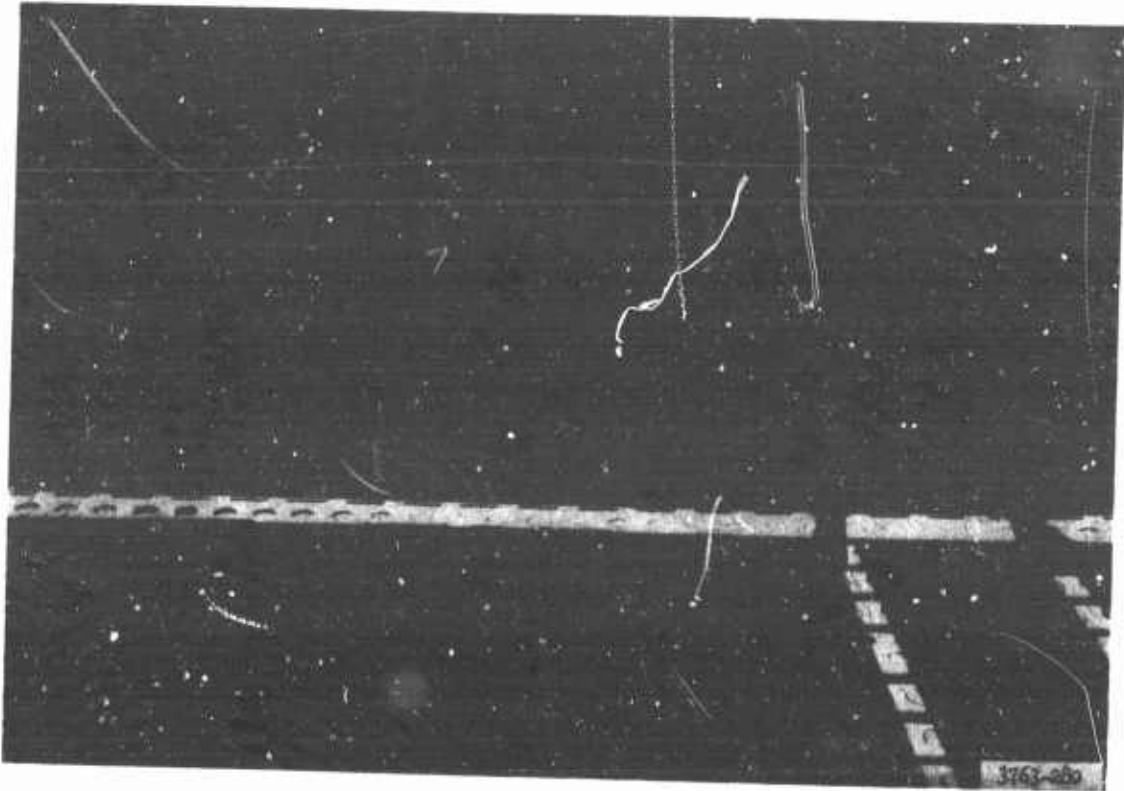
Item 3. Figure 16 shows item 3 prior to traffic. After 20 coverages the surface remained in good condition. At the 44-coverage level the

item was considered failed due to roughness (figure 17). The rated CBR was 9.0.

Figure 16. Lane 12, item 3, prior to traffic

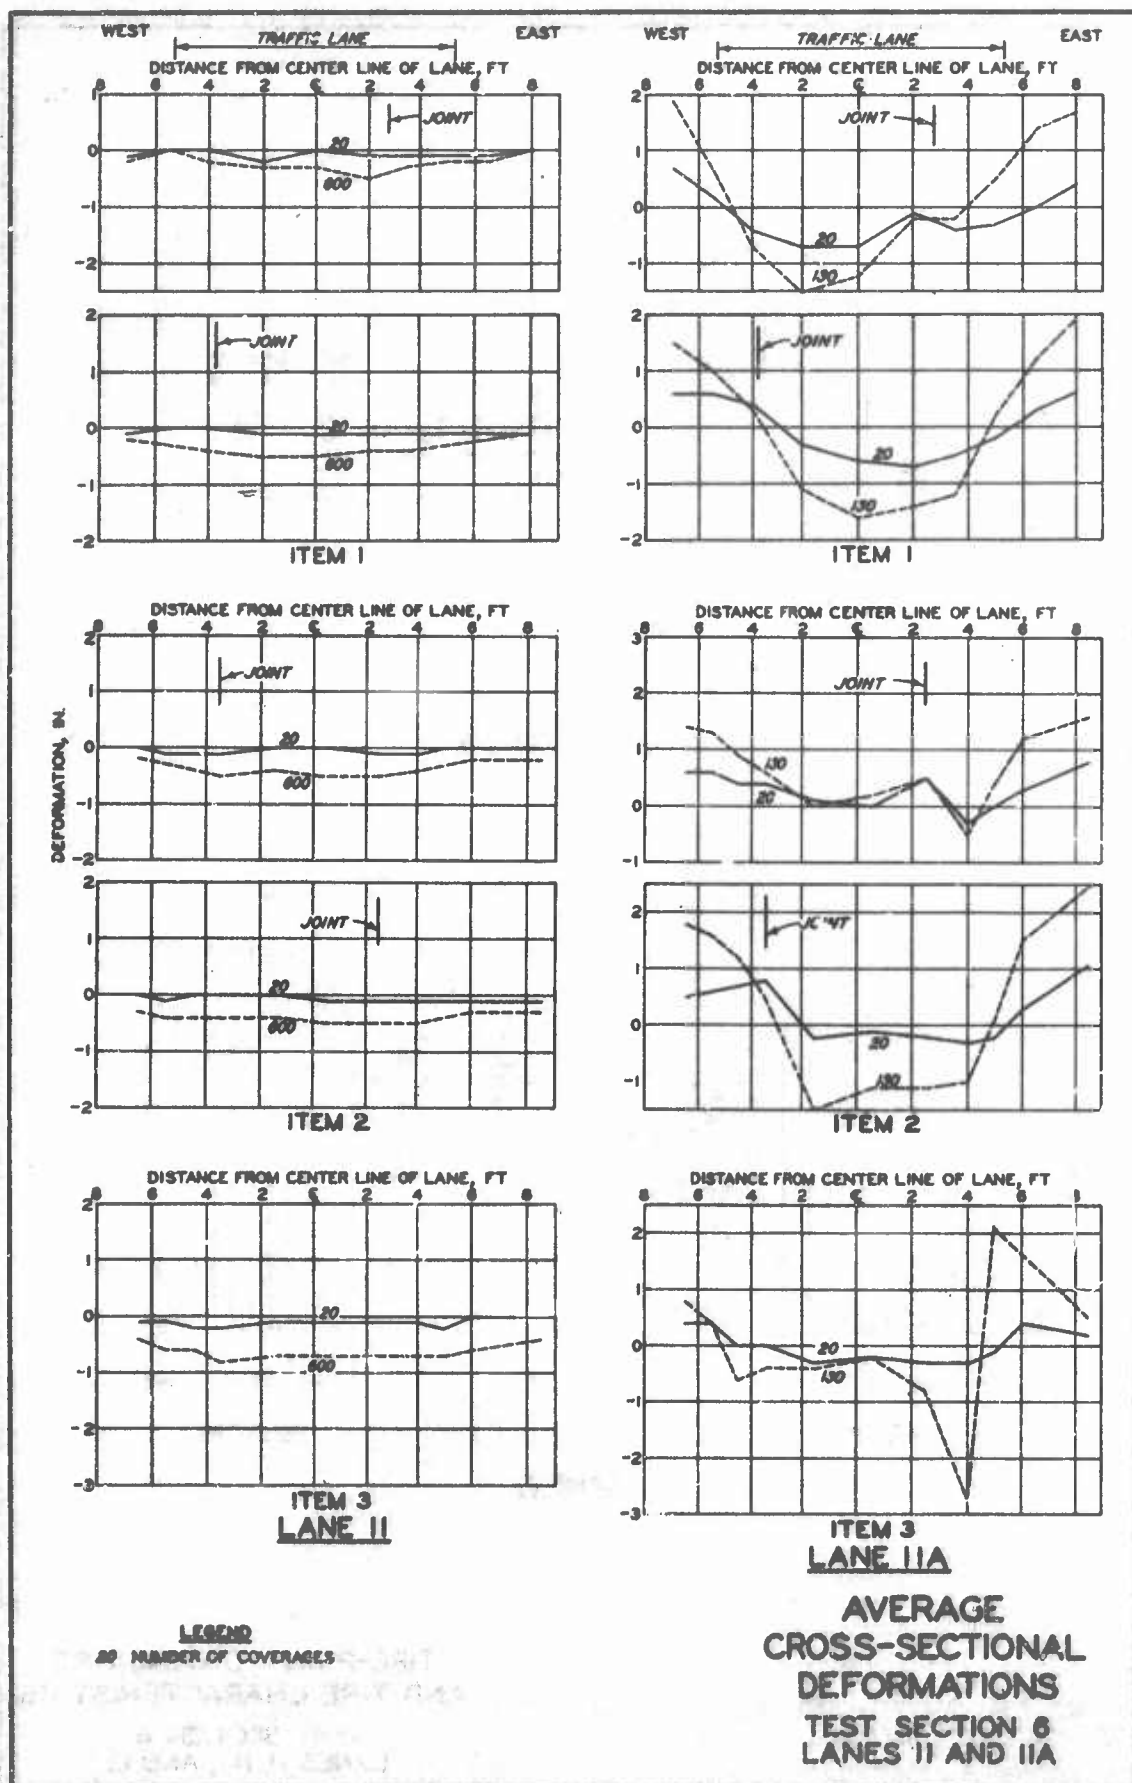
- a. Roughness. Table 1 shows the development of small differential deformations with traffic. There was some decrease in transverse and diagonal differential deformations between 300 and 600 coverages. Rut depths also showed a decrease at 600 coverages.
- b. Deformation. Figure 21 presents the average cross-section deformations at the 20- and 600-coverage levels. Profile plots along the item center line are shown in figure 22. Cross-section and profile plots illustrate the generally uniform subsidence of the item under traffic.

- b. Deformation. Figure 21 shows average cross-section deformations at 20 and 130 coverages for two typical mat runs. Center-line profiles at the same coverage levels are shown in figure 22.

- b. Deformation. Figure 21 shows average cross-section deformations at 20 and 130 coverages for two typical mat runs. Center-line profiles for the same coverage levels are presented in figure 22.

- b. Deformation. Figure 21 shows average cross-section deformations measured at 20 and 130 coverages. The severe rut that developed along one side of the lane is illustrated in the plot at 130 coverages. Center-line profiles along the item are shown in figure 22 for 20 and 130 coverages.

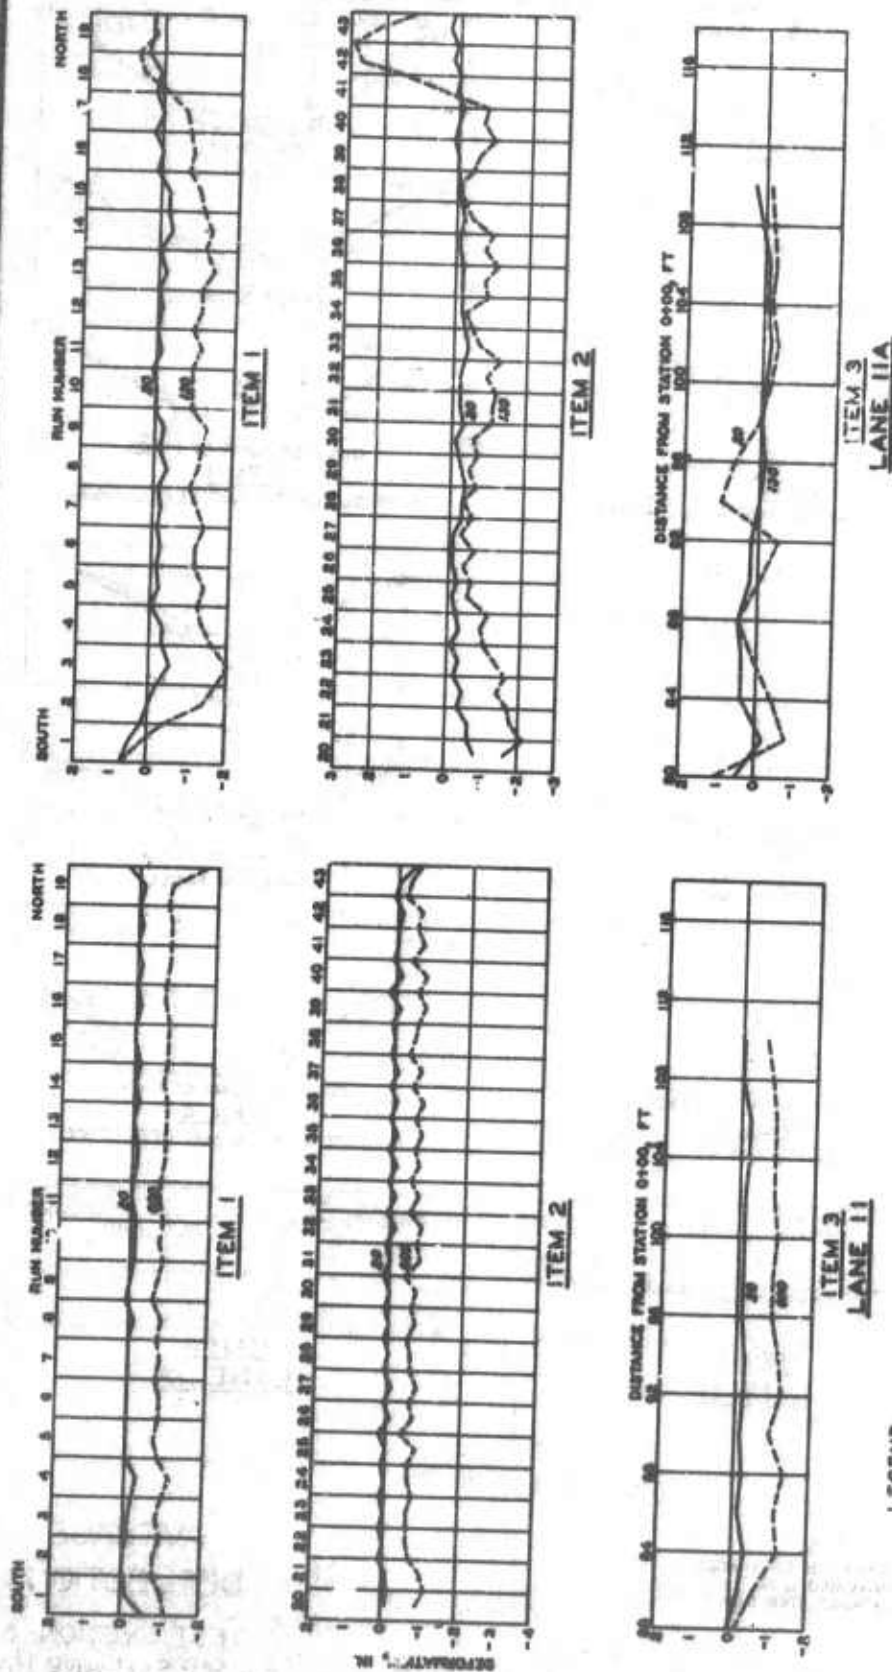
**PERMANENT PROFILE
DEFORMATIONS**
TEST SECTION 6
LANES II AND IIA

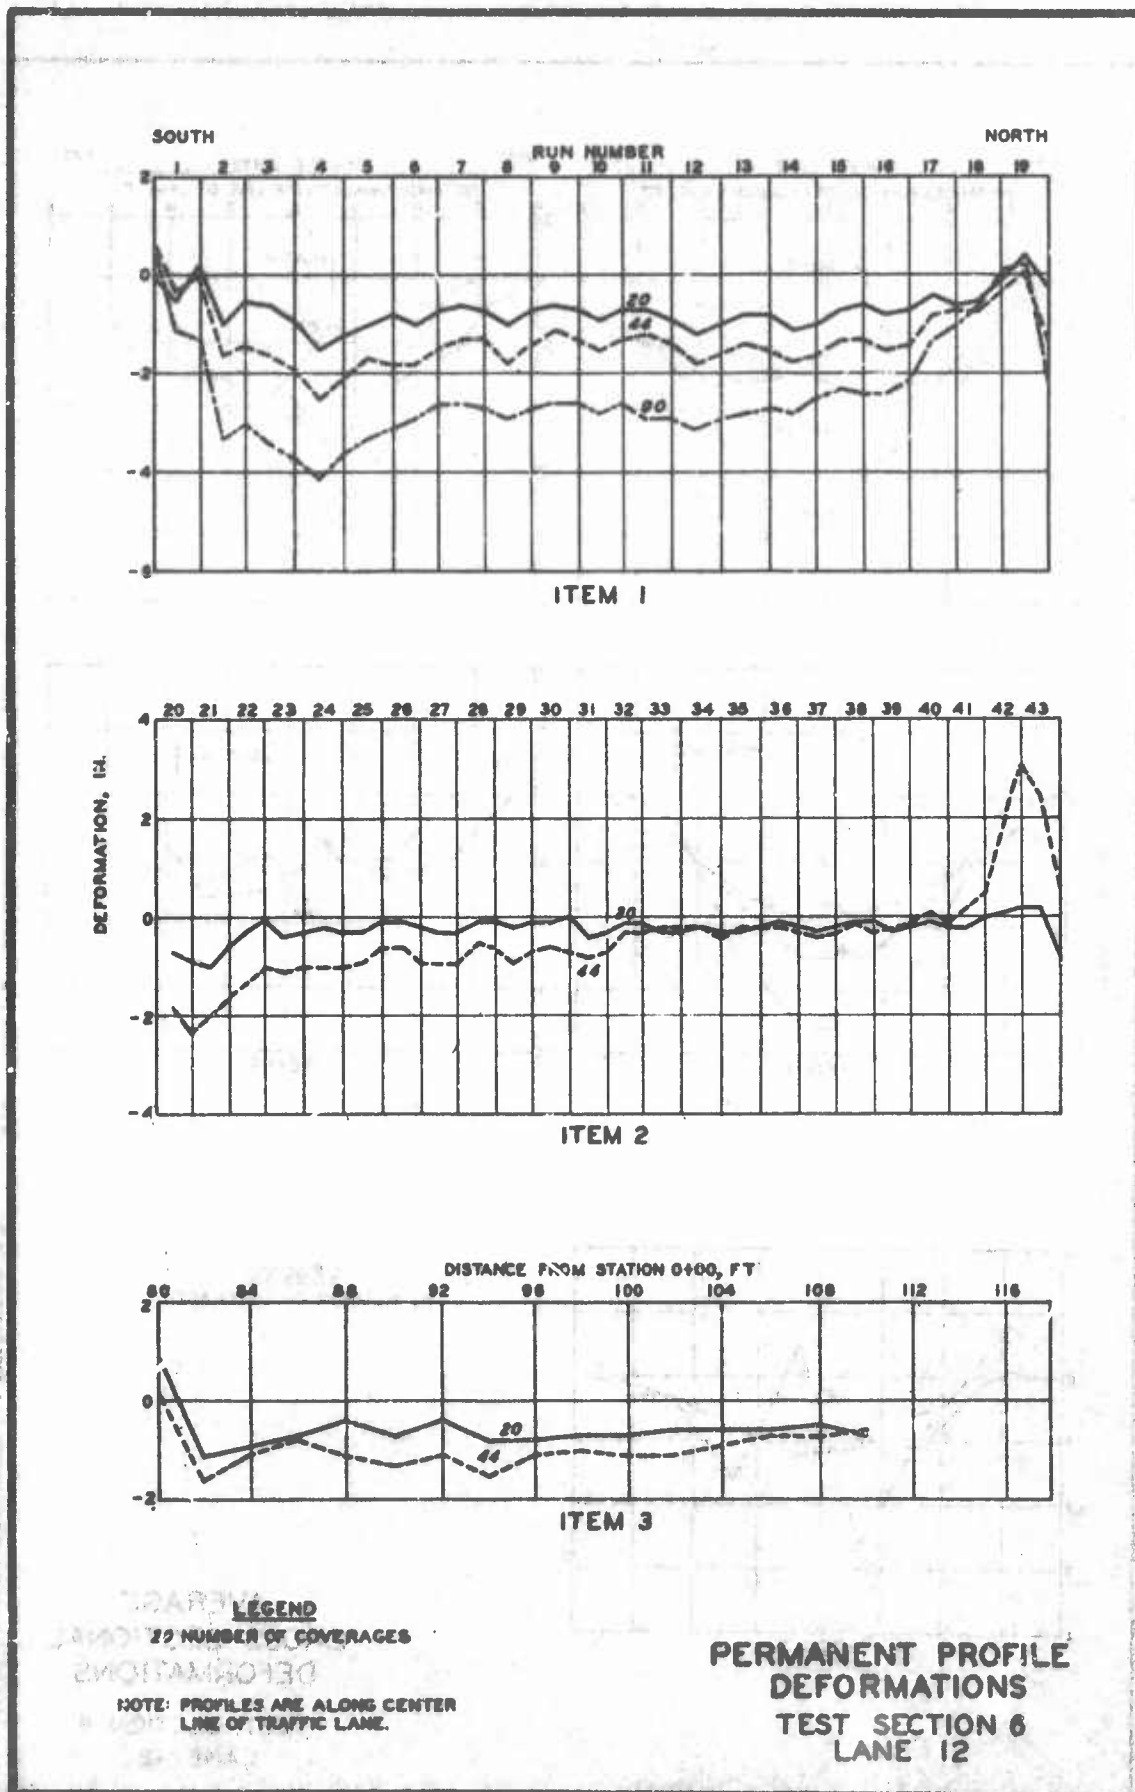
Figure 25

- b. Deformation. Figure 24 shows average cross-section deformations at several coverage levels for two typical mat runs. Center-line profiles are shown in figure 25. Deformations are seen to follow a consistent pattern of increasing severity with trafficking, reaching maximum values at failure of the item.

- b. Deformation. Figure 24 shows average cross-section deformations at 20 and 44 coverages for two typical mat runs. Center-line profiles are shown in figure 25 for the same coverage levels. The downward bend of the panel ends along the mat joint line near the lane center is illustrated in a cross-section plot (figure 24). In previous tests, the panel ends along a mat joint line most commonly protruded upward at failure, as was the case at 20 coverages in this item.

- b. Deformation. Average cross-section deformations are shown in figure 24 for 20 and 44 coverages; severe rutting of the surface is reflected. Center-line profile deformations are shown in figure 25.
